CASTILLO DE SAN MARCOS

NATIONAL MONUMENT

HISTORIC RESOURCE STUDY

**CASTILLO DE SAN MARCOS
NATIONAL MONUMENT
HISTORIC RESOURCE STUDY**

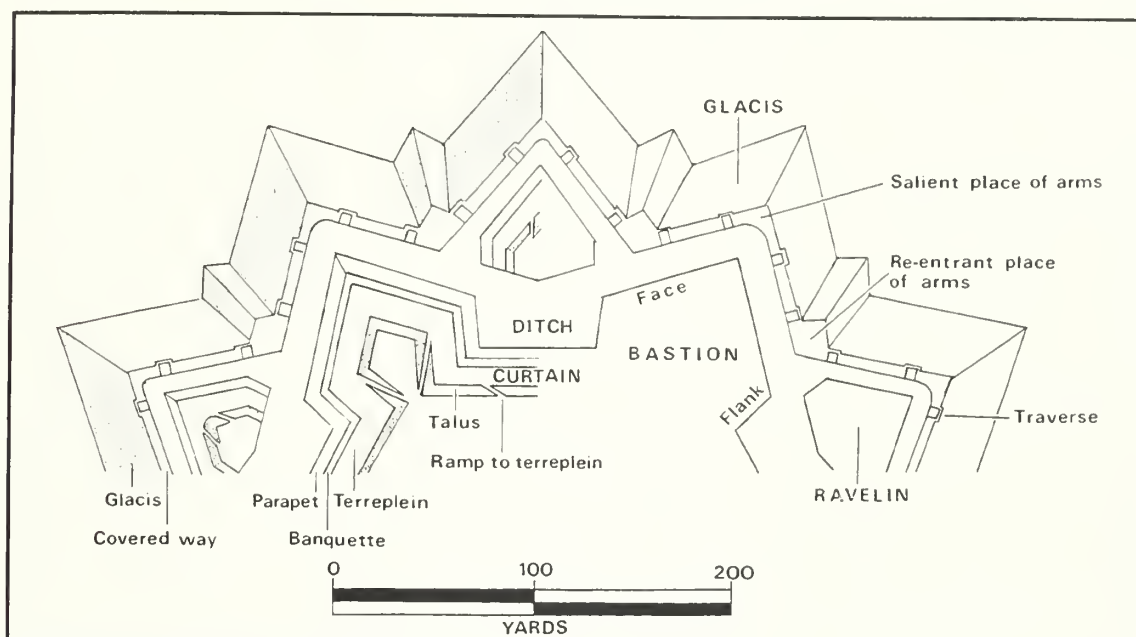
Figure 4. Plan of a simple bastioned fort

The bastion system evolved out of the medieval castle form. Engineers lowered castle walls and placed mounds of earth in front of them, creating ramparts able to withstand cannon bombardment. Moats remained an integral part of the defenses to prevent enemy forces from scaling the sloped embankments and entering the fort. The circular castle tower evolved into the angular bastion, which afforded protection to adjacent walls. Beyond the fortress walls engineers placed a variety of masonry and earthen outer works that strengthened the fort's defenses.¹¹

fortress and allowed the defenders to move farther into the landscape against the enemy. As a complete defensive fortification, the bastioned fort and its outer defenses provided a great deal of security to its occupants during a siege, although a persistent enemy might breach the walls given sufficient time and manpower.¹³

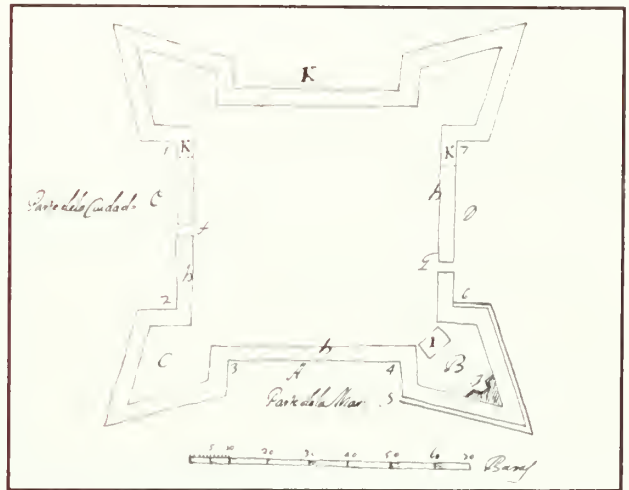
Figure 5. Plan of Castillo, 1675

Local Indians, convicts, African-American slaves, and occasionally Spanish soldiers labored alongside the skilled workers imported from Cuba. Work progressed at a steady rate on the fortress, although funding shortages and disease epidemics occasionally slowed construction. By 1686, the main block of the Castillo was complete. At that time, the outer curtain walls and bastions of the fort were coquina, while the interior walls and roof were wood; the terreplein was made of tabby, a cement made of lime and seashells, laid on top of wood planks. The fort housed troop quarters, a chapel, and a number of storerooms for the garrison. Ten years later, the moat and seawall were finished, thus enhancing the Castillo's defenses.¹⁷

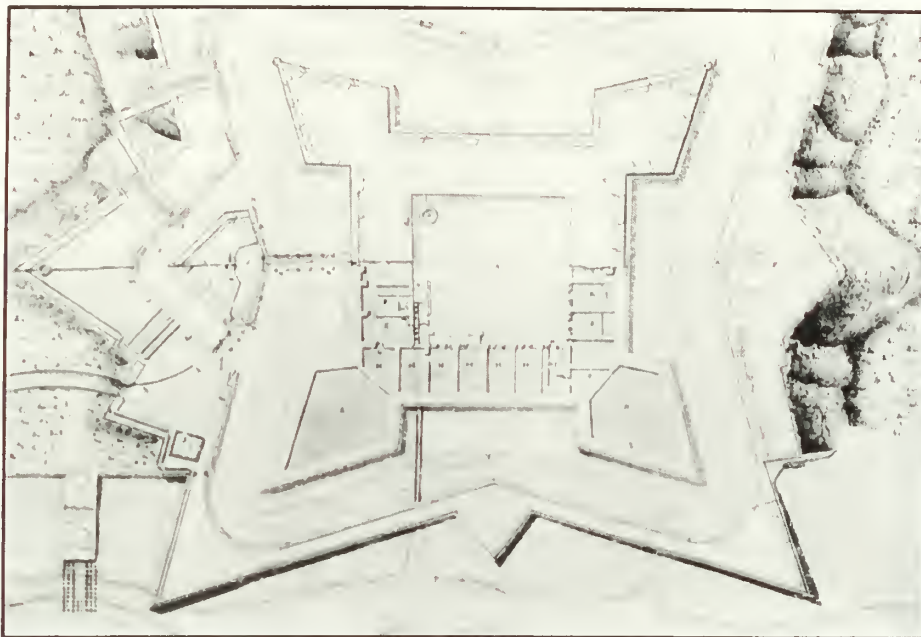
Figure 6. Plan of Castillo, 1763

the fortress walls and improved outer defense works. By 1739, the eight vaults along the east curtain wall were completed, increasing the total height of the wall five feet. The outbreak of war between England and Spain the same year slowed construction, however, and completion of the project was postponed until the end of the war.²²

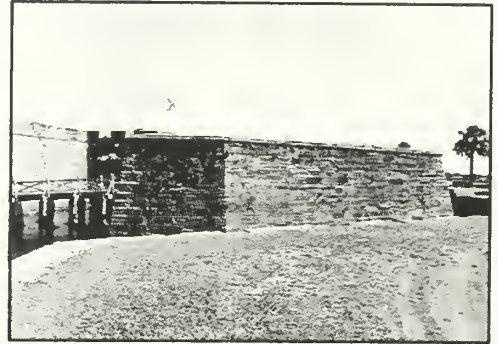
Figure 7. Ravelin viewed from west, 1995

In 1762 the Spanish undertook the last of their construction projects at the Castillo. Town residents volunteered their labor to enlarge the covered way by five feet, and masons constructed a six-foot-high stone parapet on top. Construction of the glacis was also completed at this time. Engineers determined that the original ravelin was inadequate to the defense of the fort's entrance, therefore, a new, larger ravelin, capable of housing five cannon and an underground powder magazine, was built by the end of the year.²⁴

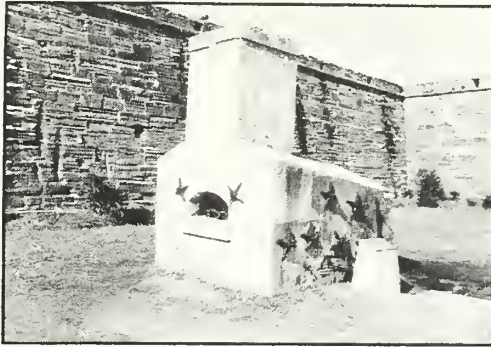
Figure 12. View of hot shot furnace from south, 1995

Hot shot furnace, 1842: Stuccoed coquina furnace measuring nine feet long by eight feet wide has a chimney eleven feet high on the south end. Small arched openings with lintels provide access to the interior of the furnace on the south and north ends. The exterior of the structure is marked with iron crossies on all sides. The hot shot furnace sits on top of the water battery on the east side of the fort. (structure; IDLCS 91419)

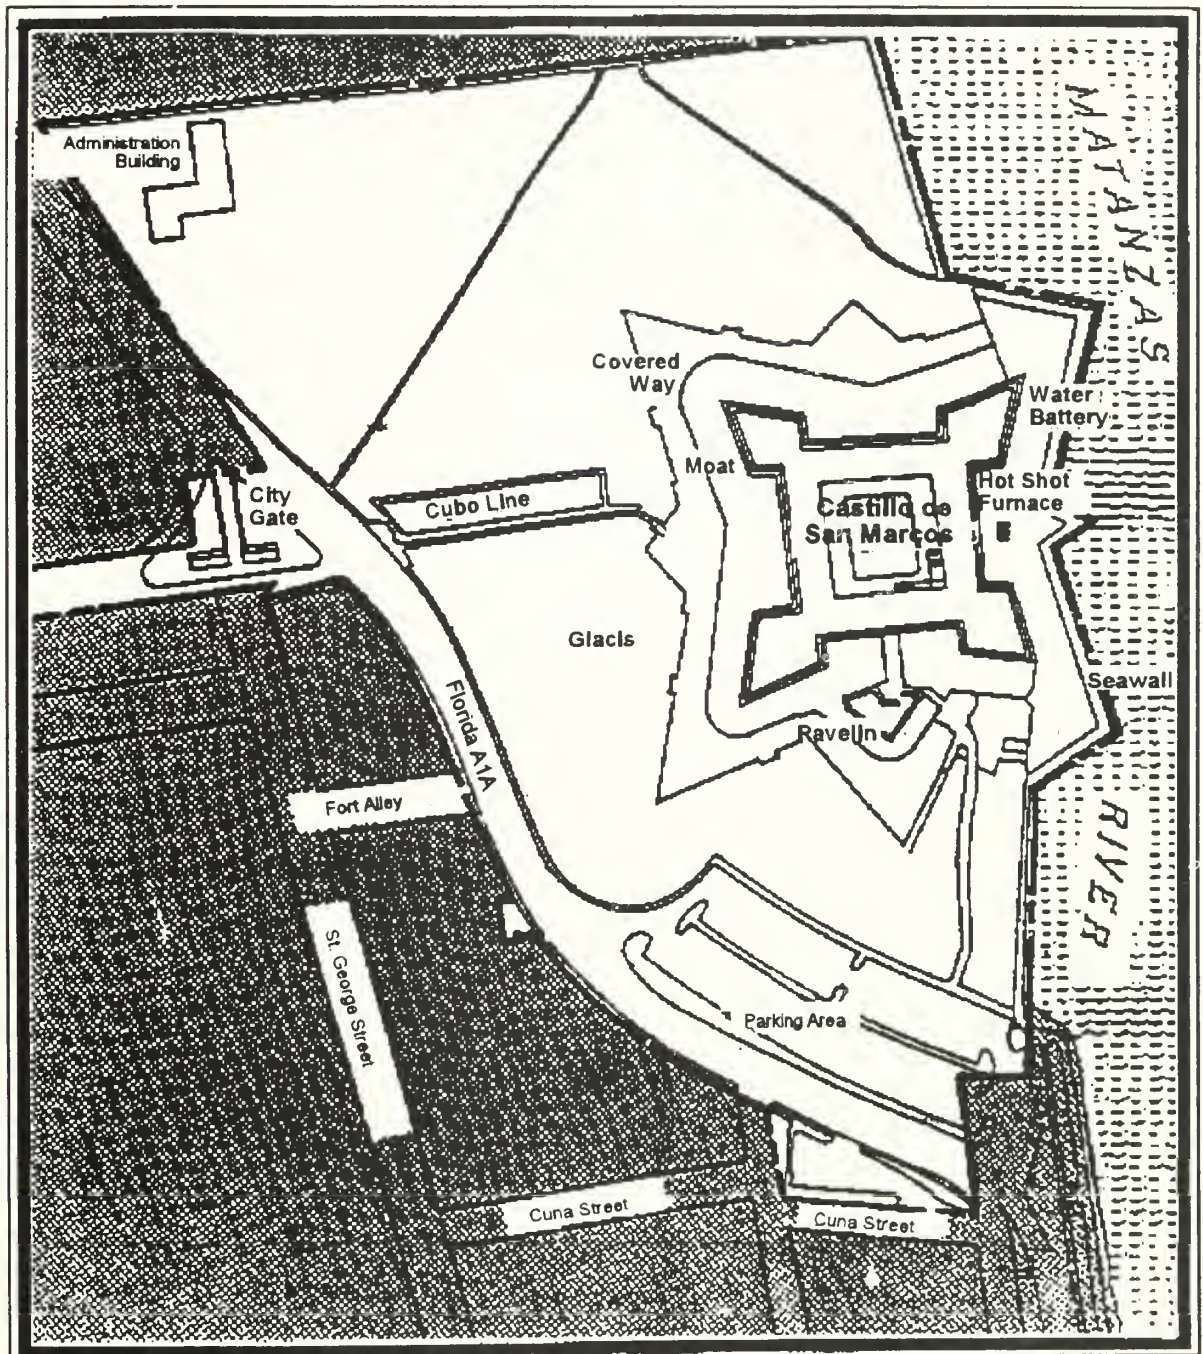
Castillo de San Marcos National Monument
Historical Base Map

The historical base map (Appendix B) depicts the existing historic resources within the park that are documented in this study. The map shows the Park boundaries, nearby bodies of water, and major area highways. National Park Service maps prepared by the Denver Service Center for the Park's General Management Plan served as the basis for the maps included in this study. The historical base map does not attempt to depict a historic scene or identify nonextant historic structures.
